Home Report

Scottish Single Survey

Single Survey

Property address	Flat B 104 Titchfield Street Kilmarnock KA1 1PH
Customer	Mr S Dunlop
Customer address	Flat B 104 Titchfield Street Kilmarnock KA1 1PH
Prepared by	Shepherd Chartered Surveyors
Date of inspection	13/03/2026

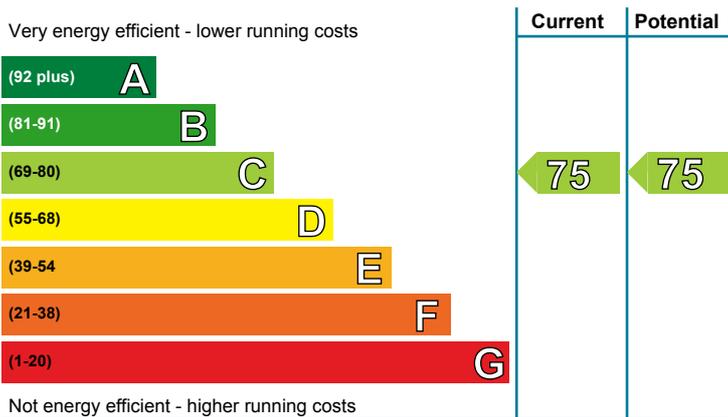
Energy Efficiency Rating

This graph shows the current efficiency of your home, taking into account both energy efficiency and fuel costs. The higher this rating, the lower your fuel bills are likely to be.

Your current rating is **band C (75)**. The average rating for EPCs in Scotland is **band D (61)**.

The potential rating shows the effect of undertaking all of the improvement measures listed within your recommendations report.

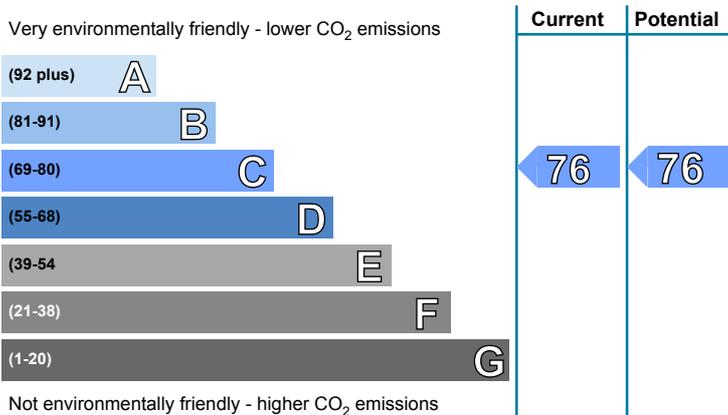
Environmental Impact (CO₂) Rating

This graph shows the effect of your home on the environment in terms of carbon dioxide (CO₂) emissions. The higher the rating, the less impact it has on the environment.
