91 Dewar Street,  
Dunfermline,  
KY12 8AB

# Home Report

# Single Survey

<b>Property Address</b>	91 Dewar Street, Dunfermline, KY12 8AB
<b>Reference</b>	1481288
<b>Customer Name</b>	Euan Duncan McLeod McCowan
<b>Date of Inspection</b>	13th March 2026
<b>Surveyor's name, qualifications and office</b>	Christopher Stark BSc(Hons) MRICS DM Hall LLP Chartered Surveyors 27 Canmore Street Dunfermline KY12 7NU  Tel: 01383 621262  email: dunfermlineresidential@dmhall.co.uk
<b>Prepared By</b>	DM Hall LLP

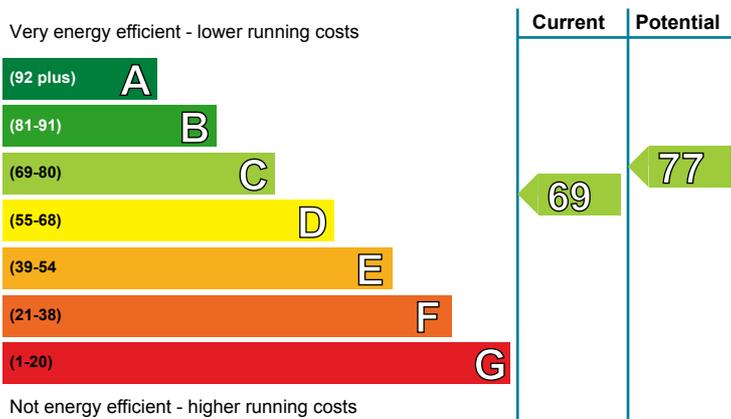
## Energy Efficiency Rating

This graph shows the current efficiency of your home, taking into account both energy efficiency and fuel costs. The higher this rating, the lower your fuel bills are likely to be.

Your current rating is **band C (69)**. The average rating for EPCs in Scotland is **band D (61)**.

The potential rating shows the effect of undertaking all of the improvement measures listed within your recommendations report.
