# Home Report

An Grianan,  
,  
Arabella,  
TAIN,  
IV19 1QH

# Single Survey

| <b>Property Address</b> | An Grianan,<br>,<br>Arabella,<br>TAIN,<br>IV19 1QH |

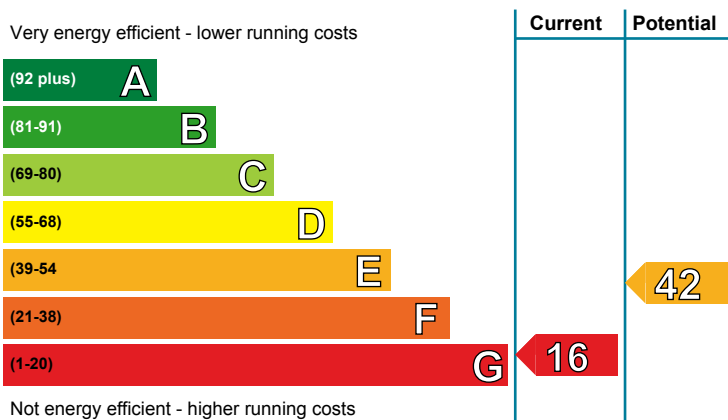
## Energy Efficiency Rating

This graph shows the current efficiency of your home, taking into account both energy efficiency and fuel costs. The higher this rating, the lower your fuel bills are likely to be.
