YOUR ONESURVEY  
**HOME REPORT**

122 Main Street  
Caldercruix  
Airdrie  
ML6 7RA

# SINGLE SURVEY

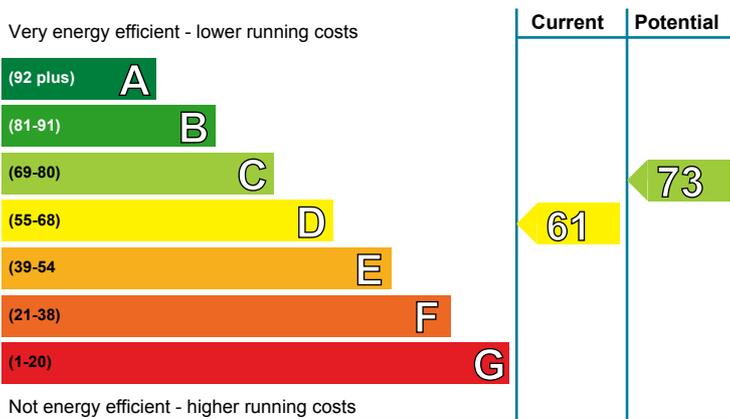
## Energy Efficiency Rating

This graph shows the current efficiency of your home, taking into account both energy efficiency and fuel costs. The higher this rating, the lower your fuel bills are likely to be.

Your current rating is **band D (61)**. The average rating for EPCs in Scotland is **band D (61)**.

The potential rating shows the effect of undertaking all of the improvement measures listed within your recommendations report.

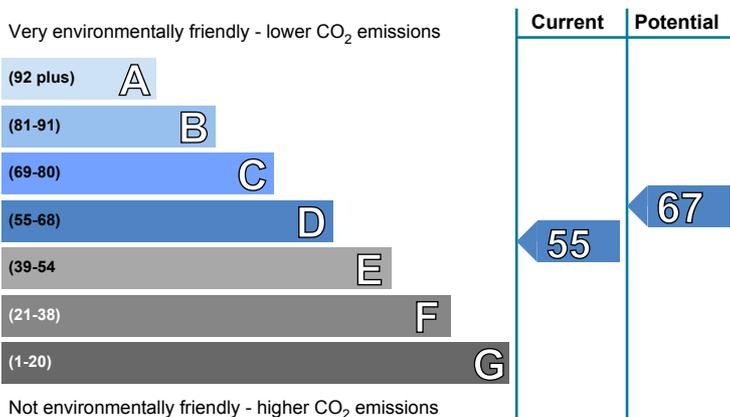
## Environmental Impact (CO<sub>2</sub>) Rating

This graph shows the effect of your home on the environment in terms of carbon dioxide (CO<sub>2</sub>) emissions. The higher the rating, the less impact it has on the environment.
