# Home Report

Braeheads 17 Maunsheugh Road  
Fenwick KA3 6DL

# Single Survey

| <b>Property Address</b> | Braeheads<br>17 Maunsheugh Road<br>Fenwick<br>KA3 6DL |

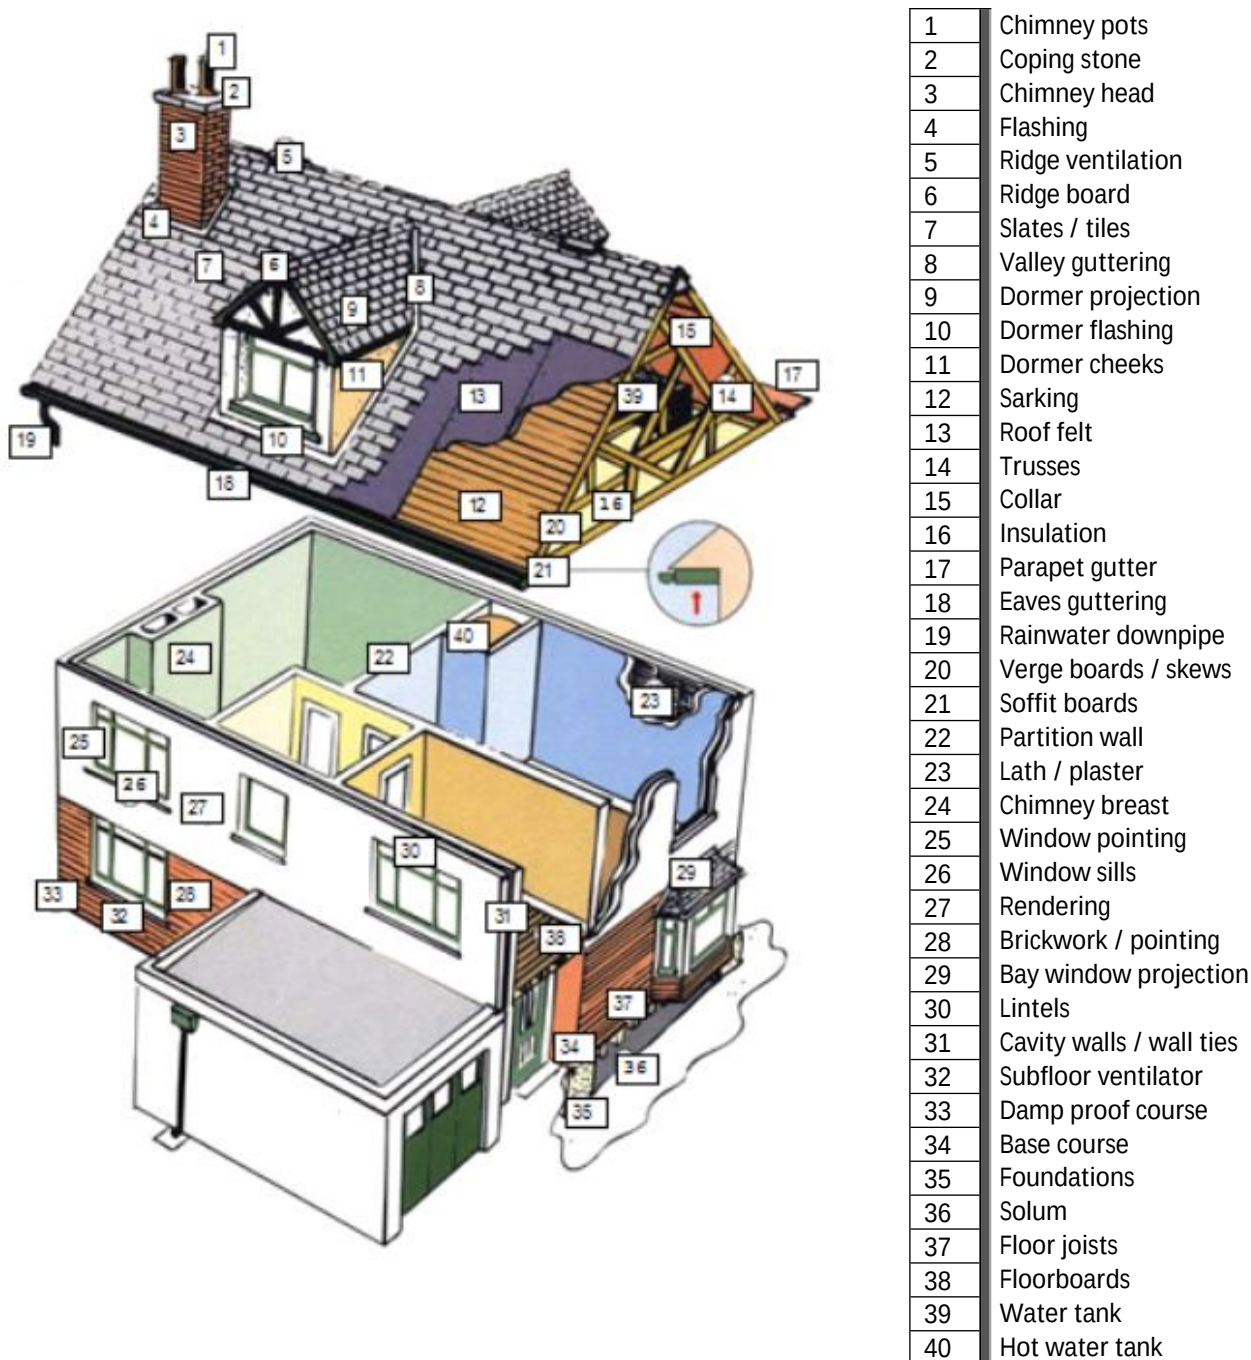
## Sectional diagram showing elements of a typical house

Reference may be made in this report to some or all of the above component parts of the property. This diagram may assist you in locating and understanding these items.
