YOUR ONESURVEY HOME REPORT

32 Crofthead Road Ayr KA7 3NB

SINGLE SURVEY

A report on the condition of the property, with categories being rated from 1 to 3.

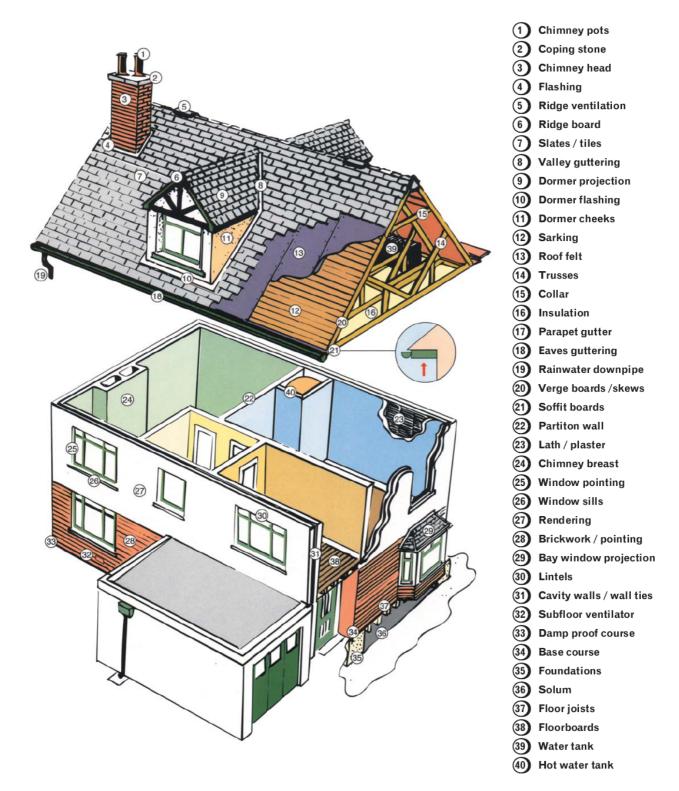
Sectional Diagram showing elements of a typical house

Reference may be made in this report to some or all of the above component parts of the property. This diagram may assist you in locating and understanding these items.
