Home Report

32 Donnini Court South Beach Road Ayr KA7 1JP

single survey

Property address	32 Donnini Court,
	South Beach Road
	Ayr
	KA7 1JP

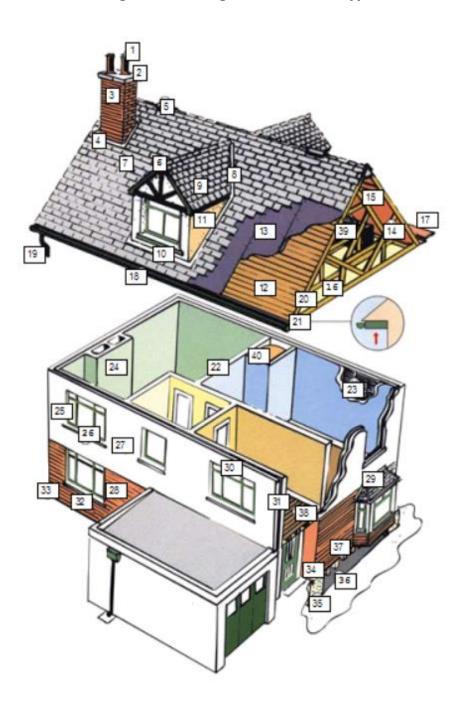
Sectional Diagram showing elements of a typical house

- Chimney pots 2 Coping stone 3 Chimney head
- 4 Flashing
- Ridge ventilation 5 6 Ridge board
- Slates/tiles
- 8 Valley guttering
- 9 Dormer projection
- 10 Dormer flashing 11 Dormer cheeks
- 12 Sarking
- 13 Roof felt
- 14 Trusses
- 15 Collar
- 16 Insulation
- 17
- Parapet gutter
- 18 Eaves guttering 19
- Rainwater downpipe 20 Verge boards / skews
- 21 Soffit boards
- 22 Partition wall
- 23 Lath / plaster
- Chimney breast
- 25 Window pointing
- 26 Window sills
- 27 Rendering
- 28 Brickwork / pointing
- 29 window Bay projection
- 30 Lintels
- Cavity walls / wall ties
- 32 Subfloor ventilator 33 Damp proof course
- 34 Base course
- 35 **Foundations**
- 36 Solum
- 37 Floor joists 38 Floorboards
- 39 Water tank
- 40 Hot water tank

Reference may be made in this report to some or all of the above component parts of the property. This diagram may assist you in locating and understanding these items.
