# YOUR ONESURVEY HOME REPORT

11b Baird Road Kilmarnock KA3 7RN

# SINGLE Survey

# Single Survey

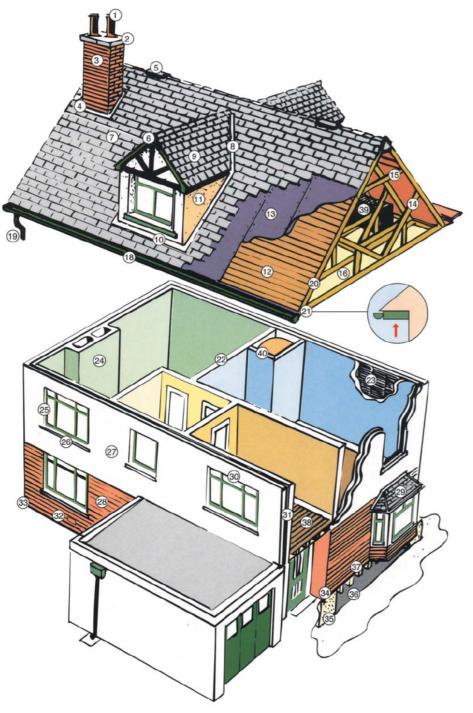
# Sectional Diagram showing elements of a typical house

Reference may be made in this report to some or all of the above component parts of the property. This diagram may assist you in locating and understanding these items.

1	Chimney pots
2	Coping stone
3	Chimney head
4	Flashing
5	Ridge ventilation
6	Ridge board
1	Slates / tiles
8	Valley guttering
9	Dormer projection
10	Dormer flashing
11	Dormer cheeks
12	Sarking
13	Roof felt
14	Trusses
15	Collar
16	Insulation
17	Parapet gutter
18	Eaves guttering
19	Rainwater downpipe
20	Verge boards/skews
21	Soffit boards
22	Partiton wall
23	Lath / plaster
24	Chimney breast
25	Window pointing
26	Window sills
27	Rendering
28	Brickwork / pointing
29	Bay window projection
30	Lintels
31	Cavity walls / wall ties
32	Subfloor ventilator
33	Damp proof course
34	Base course
35	Foundations
36	Solum
37	Floor joists
38	Floorboards
39	Water tank
40	Hot water tank

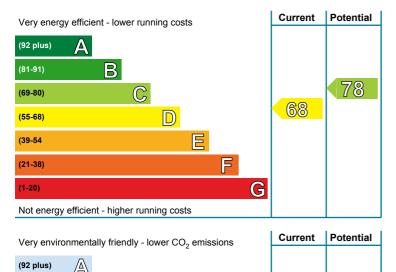
# **Energy Efficiency Rating**

This graph shows the current efficiency of your home, taking into account both energy efficiency and fuel costs. The higher this rating, the lower your fuel bills are likely to be.
