# Home report

51,  
ruthven place,  
st andrews,  
fife,  
ky16 8sj

# Single Survey

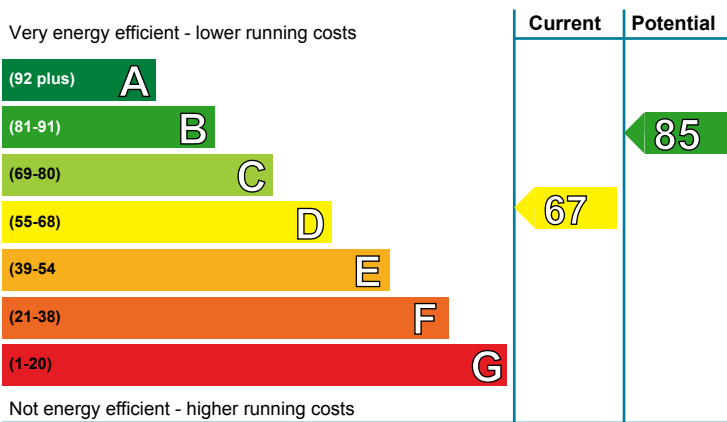
## Energy Efficiency Rating

This graph shows the current efficiency of your home, taking into account both energy efficiency and fuel costs. The higher this rating, the lower your fuel bills are likely to be.

Your current rating is **band D (67)**. The average rating for EPCs in Scotland is **band D (61)**.

The potential rating shows the effect of undertaking all of the improvement measures listed within your recommendations report.

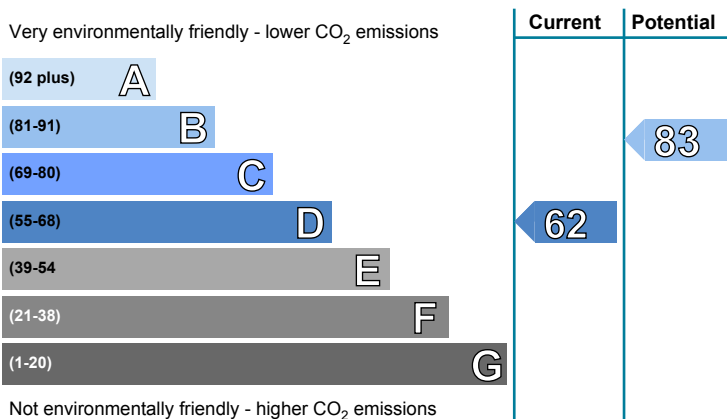
## Environmental Impact (CO<sub>2</sub>) Rating

This graph shows the effect of your home on the environment in terms of carbon dioxide (CO<sub>2</sub>) emissions. The higher the rating, the less impact it has on the environment.

The potential rating shows the effect of undertaking all of the improvement measures listed within your recommendations report.
