## Home Report

Fairliecrevoch Farm Cunninghamhead Kilmarnock KA3 2PD

# single survey

Property address	Fairliecrevoch Farm House Cunninghamhead Kilmarnock KA3 2PD

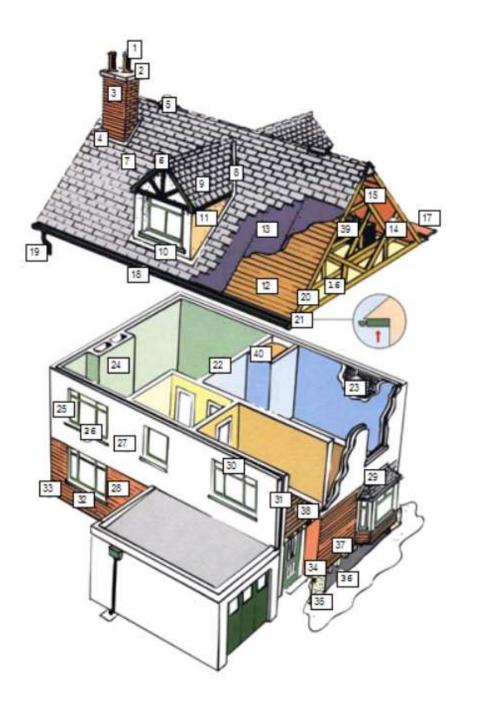
### Sectional Diagram showing elements of a typical house

1	Chimpov pots
1 2	Chimney pots
2	Coping stone
	Chimney head
4 5	Flashing
	Ridge ventilation
6	Ridge board
7	Slates/tiles
8	Valley guttering
9	Dormer projection
10	Dormer flashing
11	Dormer cheeks
12	Sarking
13	Roof felt
14	Trusses
15	Collar
16	Insulation
17	Parapet gutter
18	Eaves guttering
19	Rainwater downpipe
20	Verge boards / skews
21	Soffit boards
22	Partition wall
23	Lath / plaster
24	Chimney breast
25	Window pointing
26	Window sills
27	Rendering
28	Brickwork / pointing
29	Bay window
	projection
30	Lintels
31	Cavity walls / wall ties
32	Subfloor ventilator
33	Damp proof course
34	Base course
35	Foundations
36	Solum
37	Floor joists
38	Floorboards
39	Water tank
40	Hot water tank

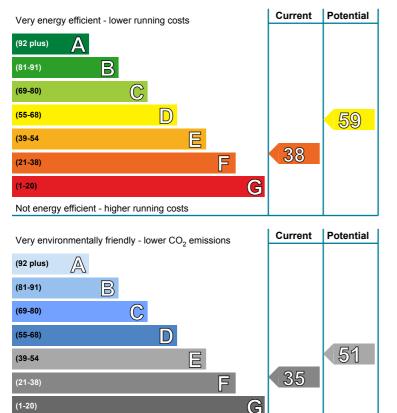
#### **Energy Efficiency Rating**

Not environmentally friendly - higher CO<sub>2</sub> emissions
