HARVEY DONALDSON & GIBSON

survey report on:

Property address	11 Hillview Crescent, Rosehearty, Fraserburgh, Aberdeenshire, AB43 7JF
Customer	Mr & Mrs A Westlake
Customer address	41 Queen Street, Cardiff, CF15 7NN

PART 1 - GENERAL

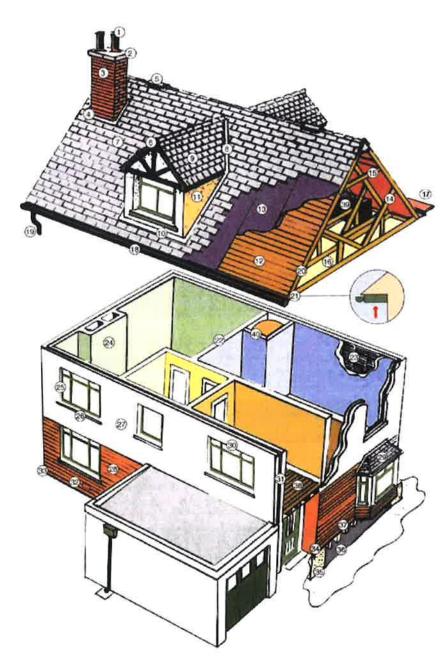
Sectional Diagram showing elements of a typical house

Reference may be made in this report to some or all of the above component parts of the property. This diagram may assist you in locating and understanding these items.

- Chimney pots
- Coping stone
- (3) Chimney head
- (4) Flashing
- (5) Ridge ventilation
- Ridge board
- 7 Slates / tiles
- Valley gutlering
- 9 Dormer projection
- (10) Dormer flashing
- (11) Dormer cheeks
- 12) Sarking
- (13) Roof felt
- 14) Trusses
- (15) Collar
- (16) Insulation
- (17) Parapet gutter
- (18) Eaves guttering
- (19) Rainwater downpips
- (20) Verge boards/skews
- (21) Soffit boards
- (22) Partition wall
- (23) Lath / plaster
- (24) Chimney breast
- (25) Window pointing
- (26) Window sills
- (27) Rendering
- (28) Brickwork / pointing
- (29) Bay window projection
- (30) Lintels
- (31) Cavity walls / wall ties
- (32) Subfloor ventilator
- (33) Damp proof course
- (34) Base course
- (35) Foundations
- (36) Solum
- (37) Floor joists
- (38) Floorboards
- Water tank
- (40) Hot water tank
