SINGLE SURVEY REPORT

PROPERTY ADDRESS	28/2 Piersfield Grove Edinburgh EH8 7BX
CLIENT	Mr Scott Robertson
CLIENT ADDRESS	c/o Mackay Sinclair WS 11-15 Easter Road Edinburgh EH7 5PJ
DATE OF INSPECTION	17 July 2020
PREPARED BY	DIXON HEANEY KEAN KENNEDY Chartered Surveyors 54 Corstorphine Road Edinburgh EH12 6JQ Tel: 0131 313 0444 Fax: 0131 313 0555 Email: survey@dhkk.co.uk

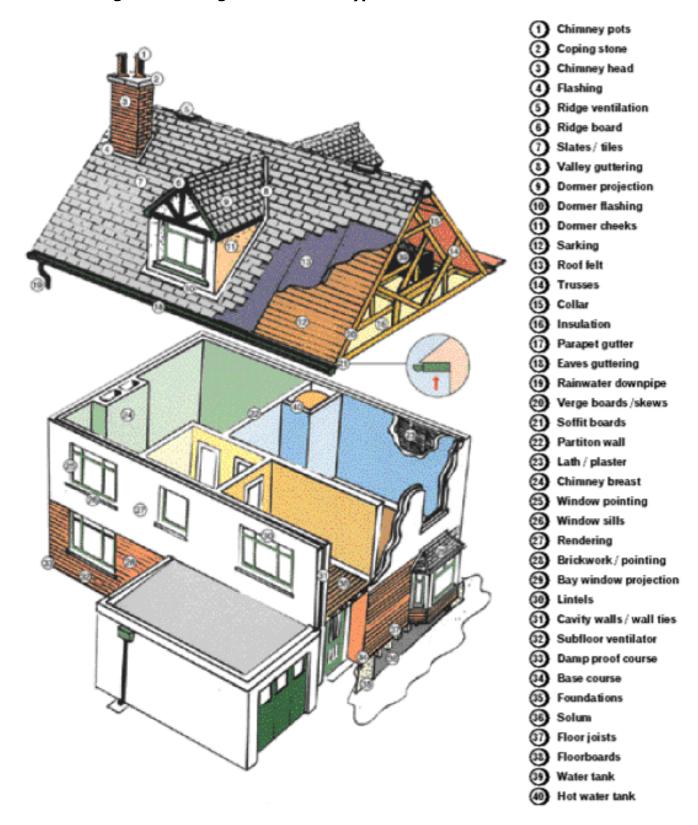
Sectional diagram showing elements of a typical house

Reference may be made in this report to some or all of the above component parts of the property. This diagram may assist you in locating and understanding these terms.
